EMITIMING installation

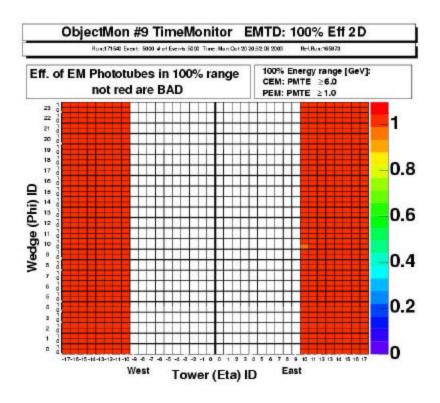
Efficiency - almost all channels are 100% efficient above 2 GeV

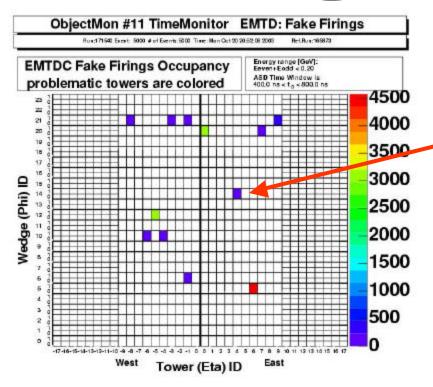
Fake hits in central will disappear if we install ASD boards

Do we have fake hits – TDC hits when there is no energy in the tower - No

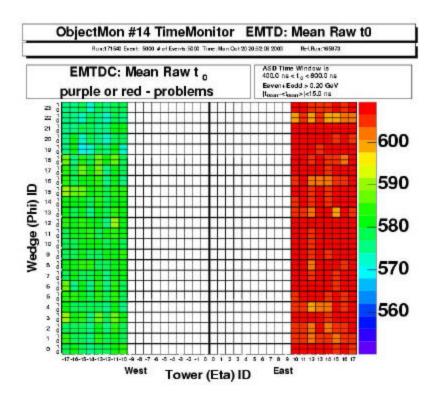
Mean T0 – looks fine

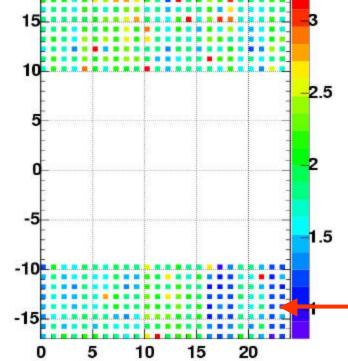
ASD thresholds – all channels will look like that after today
